# 1. Introduction

# 2. Previous Installation

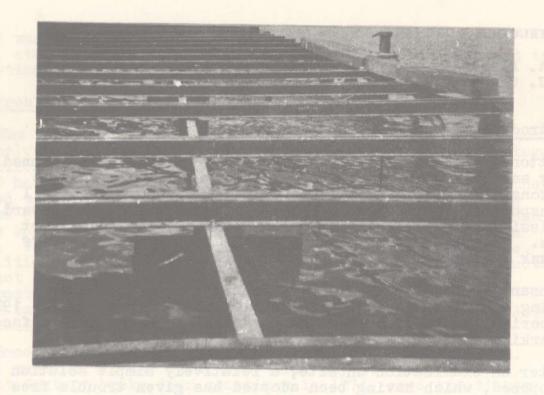
Extensive deterioration of the jetty timber deck, however, was the chief cause of the poor service by the pier.

All evidence indicated that in the past, the repair work to the timber deck had been confined to the top members only and

View on Jetty Steel Substructure after removal of timber deck. 20th June, 1972.

consequently the progressive deterioration of the timber bearers below gave rise to the deck failure.

Preliminary calculations showed that the dead weight of a concrete deck need not differ from that of the then existing timber deck. The steel supporting structure could therefore be re-used.

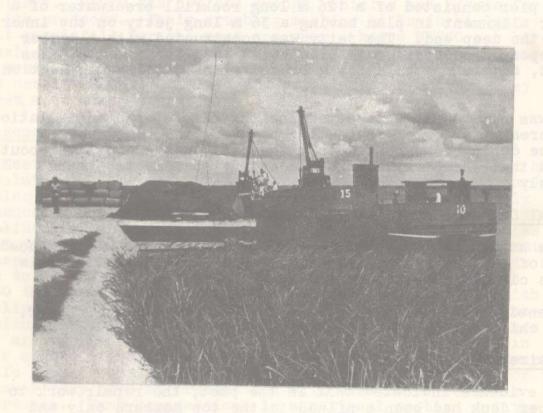
Solima Pier in Use. August, 1972.

By 15th August, 1972 all the works were completed, some two weeks ahead of programme.
