CASE STUDIES: IN-SITU REBUILDING OF DAMAGED ROPE DRUM SHAFTS OF SSG CRANE AND THE REPAIR OF CIRCUMFERENTIAL CRACK OF CEMENT KILN BY WELDING.

Joseph Runyoro

CASE STUDY 1 RECONDITIONING OF DN 240 ROPE HOIST DRUM SHAFT OF A SHIP TO SHORE GANTRY CRANE.

CASE NO 2. WELDING OF THE CIRCUMFERENTIAL CRACKS OF WELDED JOINT OF THE CEMENT KILN

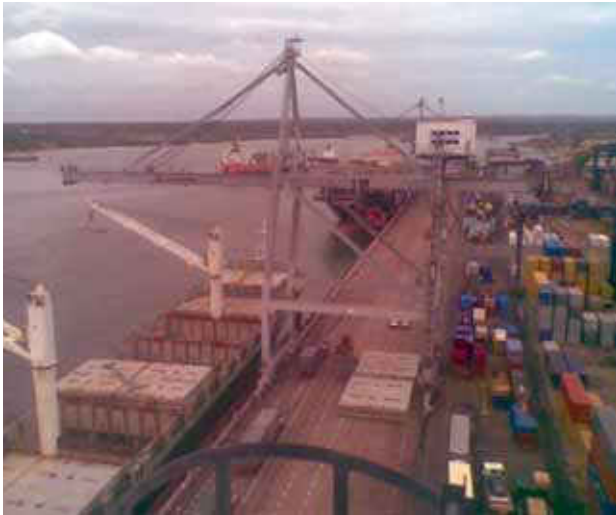
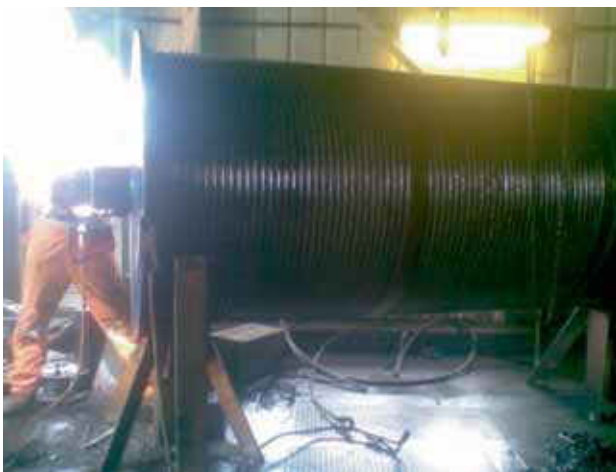
It is not the aim of this article to discuss why the bearing failed and caused such damage to the shaft without being noticed on time. It has to be taken into account that the main rope hoist drum is situated at the height of over 40 meters above the ground and the room is equipment with motors and gearboxes which makes a lot of noise. Therefore it would have

Fig. 1: at the bottom is the structure of SSG Crane showing a white box where the winching system is located. At the top is typical rope hoist drum, being repaired.

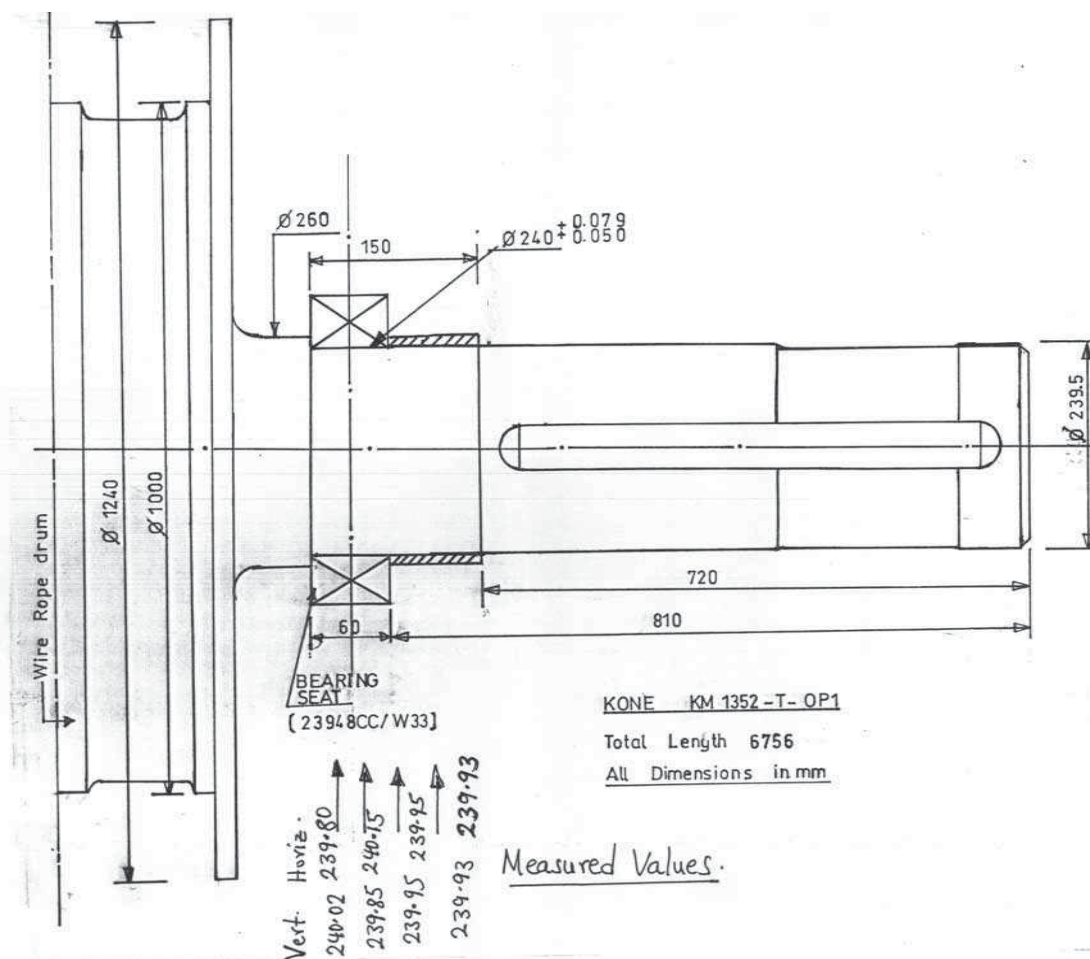
the company informing them the extent of failure. One of the hoisting rope drum bearing on the drive side failed by cracking into small pieces and has worn down the shaft up to 239.80 mm. The required size was between 240.079 and 240.057 in diameter so that the bearing can fit. The distance of the drive end shaft to the center of the bearing was 840 mm, and the thickness of the bearing was 60 mm. (Fig. 3). The procedure for building up of the worn out part was proposed and was approved by the client and the machinist.

Fig. 3 Sample of drawing sent to the machinist so that the right machining equipment can be selected

The chemical composition analysis of the shaft material confirmed that the material was BS 4360 50C material, but due to its size, it needed preheating in order to weld without the possibility of cracking. The E 7018-1 type of electrodes with basic coating and with extra low moisture content and good resistance to moisture pick-up was selected. It is suitable for

welding high tensile steels sensitive to hydrogen embrittlement. These include hardenable low alloy structural steel and carbon steel particularly when preheating cannot be used or when the moisture content of the coating is critical. It was proposed that the shaft be rebuilt using 3.2 mm diameter, E 7018-1 stick electrodes with electrode connected to DC +ve. The selection of the rectifier and electrodes was based on the fact that low heat input was preferred to minimize shaft distortion, cracking, and hard deposited weld metal due to carbon pick-up from the parent metal (Table 1). The transverse welding taken along the axis of the shaft is superior in fatigue properties than circumferential welding, as if there is any weld metal crack formed during the welding process, it will be difficult to propagate in transverse welded metal as compared to the transverse one.

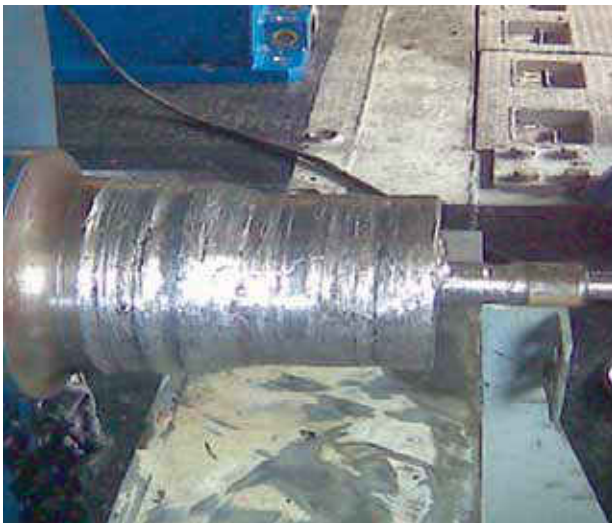
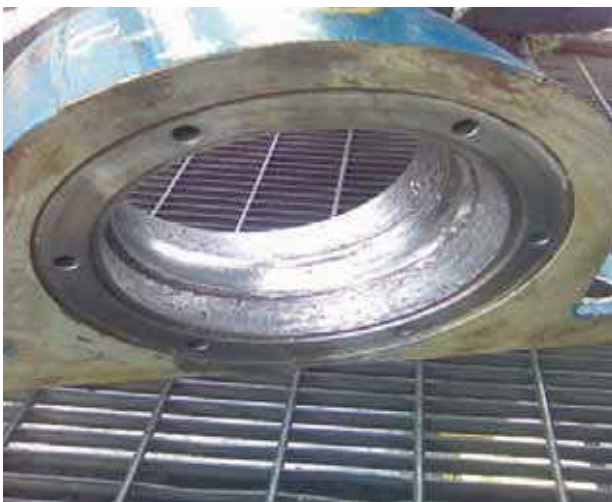
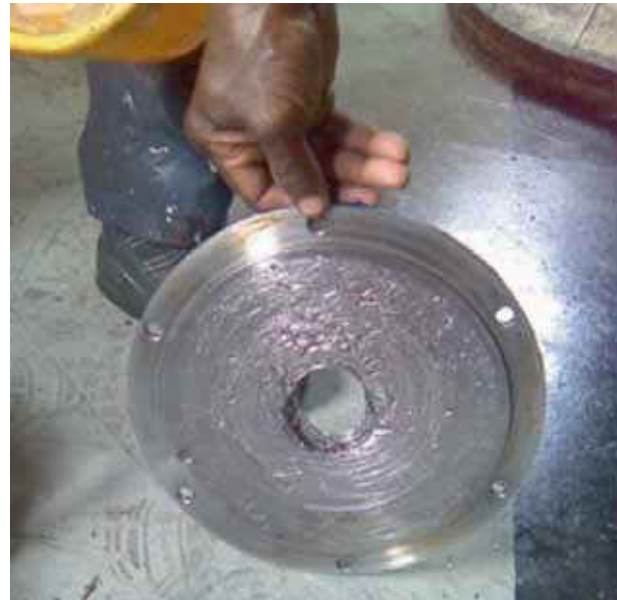
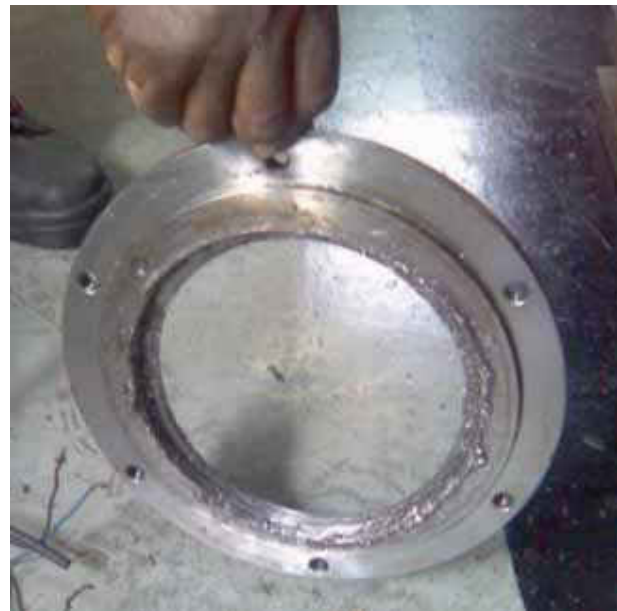
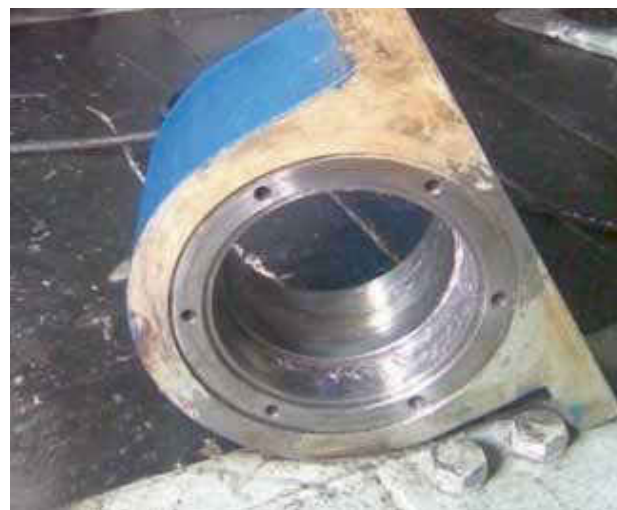
The bearing failure may have been caused by fatigue failure of one of the bearing parts, interfering with the movement of other rollers and damaging other parts of bearing housing and generating very high temperatures within the bearing due to friction between the broken bearing parts. This in turn will have caused wear on the shaft's bearing seat.

The shaft was machined and the bearing seat ground to the accuracy of k6 tolerance as shown in Table 2. The bearing was assembled and the equipment is in working order since then. Recently, another bearing on the driven side of the rope hoist drum failed as shown in Fig. 4. The damaged shaft was welded using the same procedure as that used in the first failure, and machined as shown in Fig. 5. The same machine used for machining can also be used for grinding the bearing seat. The type of the machine depends on the nature and surface to be machined. The machine used in this work is as shown in Fig. 5a. The machine used in the previous repair is as diagrammatized in Fig. 6. They are all air operated and it is more of milling process than machining as the work piece is stationary. The main problem of this type of in-situ welding of the shafts is the alignment. If the alignment is not proper, the shaft will be rotating unbalanced and will fail prematurely under fatigue mode.

Fig. 4: Damaged main rope hoist drum shaft with bearing journal and covers.

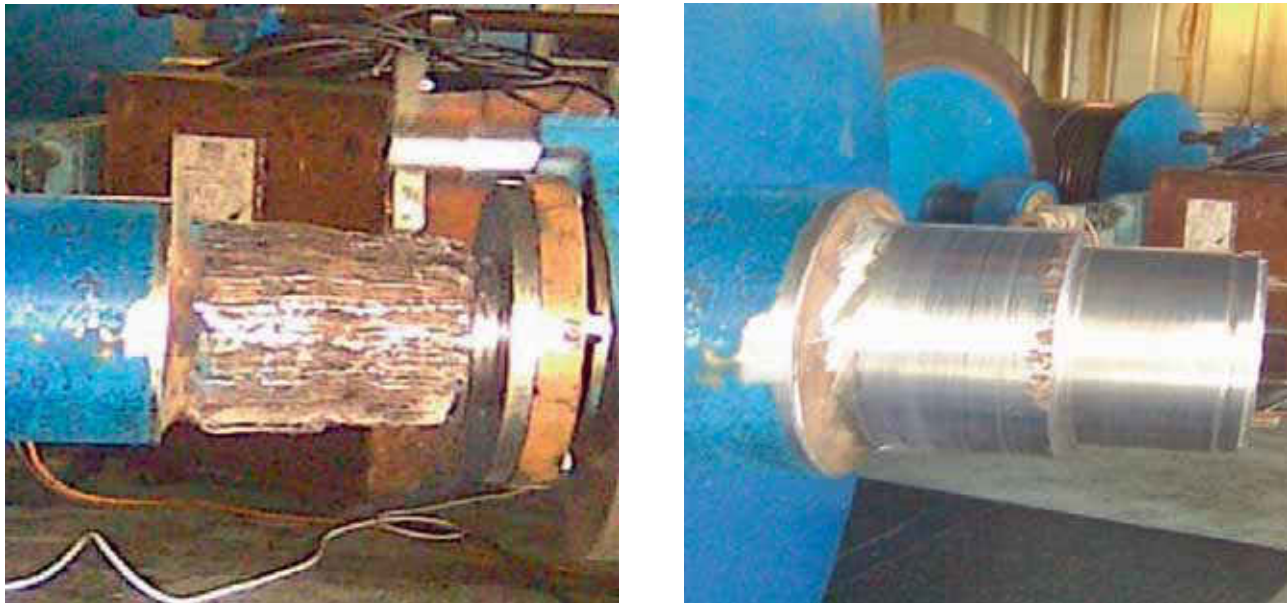
Fig. 5: Rebuilding by welding and machining of rope hoist drum shaft

The negative welding cable was connected directly to the shaft end being welded to avoid arcing through other bearings of the equipment. The shaft was preheated and kept at a temperature above 105°C by the use of flame torch during the entire welding process. In case there was a break, the welded part was covered with the insulation material to minimize the fast cooling of the weld metal.

In the rebuilding, transverse beads were deposited by skip weld process to balance the heat dissipation on the shaft and avoid bending. Beads were deposited at different locations around the circumference of the shaft until the entire shaft was filled. The skip weld process was repeated until successive spaces between the original beads were gradually closed in and the entire center area of the shaft overlaid. After the first layer was built up the same procedure using transverse beads was used to fill the damaged journal. Skip welds process provided proper heat distribution, minimizing thermal stresses. The electrodes used for rebuilding of the worn shaft were low hydrogen electrode of the type E 7018-1. These are suitable for welding high strength low alloy steels, as they are very resistant to hot cracking. After welding, the built-up part was heated at a temperature of around 150°C to remove residual stresses before machining to the final size.

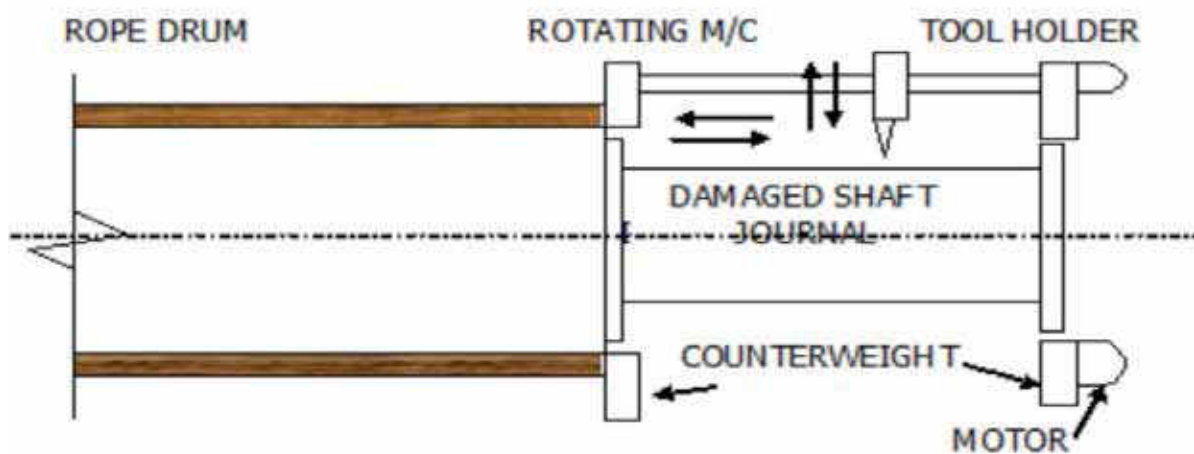
Fig. 6: Typical arrangement of air powered milling machine for turning the rebuilt by welding long shaft with a bearing journal

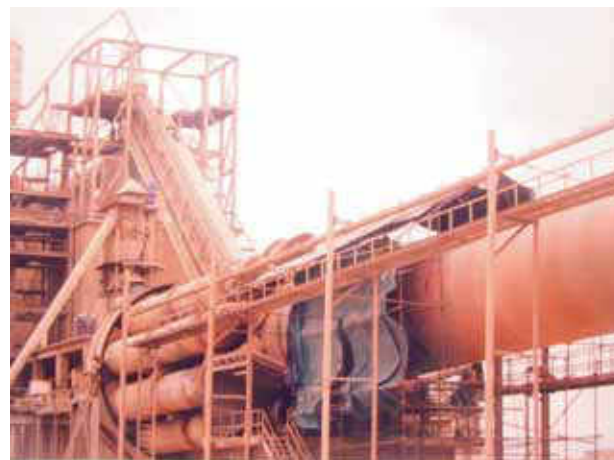
In 2002, the Cement Kiln with 3.95 m diameter and 65 m in length shown in Fig. 7, generated a circumferential crack during its operation on an overhang carrying twelve planetary coolers. The opening in the hollow shaft was detrimental in the operation of the Kiln as it would have bent and caused uneven rotation, and causing misalignment of refractory bricks. In turn the clinker heat would have penetrated through the gap between the refractory bricks and heating up the kiln steel plates, which would have caused further buckling and failure.

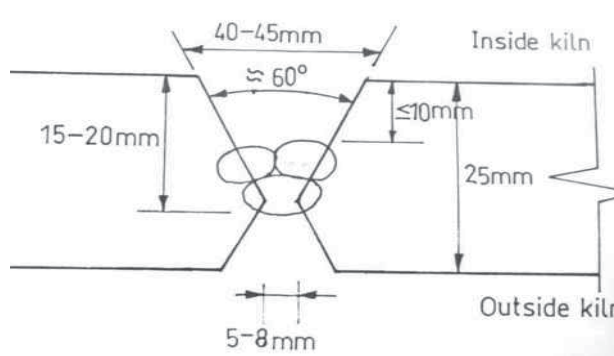
Fig. 8: Preparation of double bevel angles for the circumferential kiln shell joint

The crack occurred at 25 mm thick plate. In order to repair it, the area was gouged using arc-air to give and external and internal bevels as shown in Fig. 8. The area to be gouged was preheated at around 100 °C temperatures to prevent any crack propagation. The gouged bevel surfaces were ground to ensure that high carbon induced by gouging was removed.

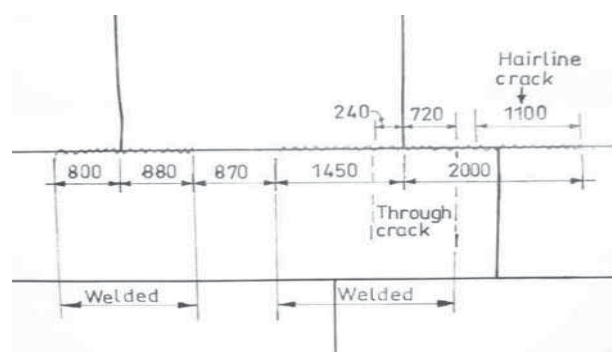
Very secure scaffolding was erected outside the kiln on circumferential welded joints for inspection. The through crack was investigated and it was found to be 640 mm in length. It was propagating through the weld metal. On the face of the weld metal, the visible cracks were extending up to 2030 mm (fig. 9). The kiln shell around the cracked joint plastically deformed due to excessive heat making the shell skin soft and due to restricted expansion of the kiln. The sharp edge of the joint were 25 mm plate met the 45 mm plate by welding was considered a stress concentration point, which is suspected to have initiated the cracking of the Kiln circumferential weld (fig. 10).

The ultrasonic crack inspection indicated that the through crack started from outside the kiln on a 25 mm plate weld fusion zone and propagated slanted through the weld metal to the 45 mm plate side of weld fusion zone inside the kiln shell for at least 500 mm length. The remaining length of 140 mm showed that the crack was perpendicular to the kiln axis. The partial cracks on the surface were found to have depth ranging from 5 – 15 mm. Cracks with depth less than 5 mm were repaired by grinding the area until the crack disappeared. Furthermore, all stress concentration raisers were removed from the weld joints by grinding off all reinforcement and blending in the joint with the immediate parent metal.

Fig. 9: The development of the kiln shell showing the affected areas.

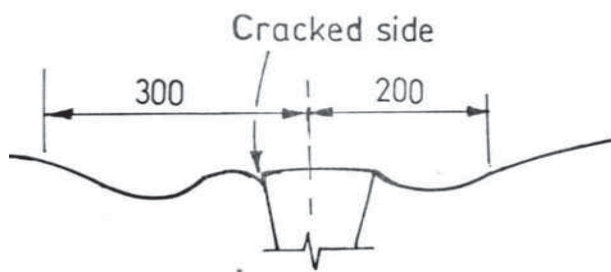
Fig. 10 Deformed shell at the welded joint.

After complete welding, the joint was heated to about 100°C and soaked for about one hour by placing the insulation blankets in order to cool slowly and achieve the desired properties in the weld metal and heat affected zones. All deformed zones along the circumferential joint which failed by cracking were ground flat both inside and outside in order to avoid stress concentration points outside and to make sure that the refractory bricks inside the kiln are laid properly to make a perfect heat seal. All the welding was carried out by qualified (Technical) welders. Non destructive testing involving magnetic particle, dye penetrant was carried out to check if there were any cracks remaining in the circumferential welded joint.

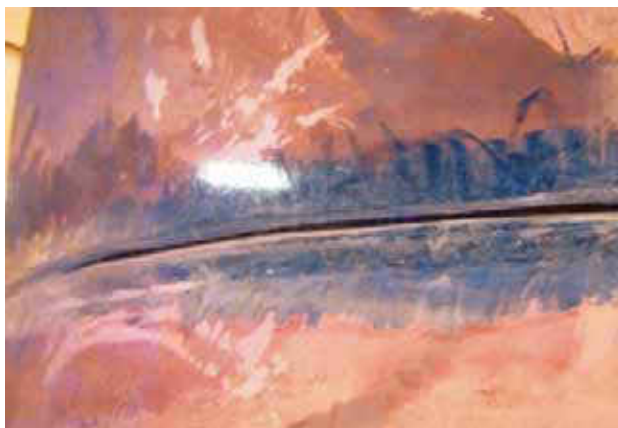
Fig. 11 Repairing of the cracked shell.

The through crack zone was gouged out to prepare the double bevel (Fig. 11). The gouged out area was inspected by dye penetrate method after grinding it to check if there is any crack. The plates to be welded were held together by strong stiffener before

being preheated to a temperature of 100 -150°C covering an area of 200 mm on either side of the crack, and the temperature was maintained in the welding zone during the repair (Table 3).

The selected electrodes for carrying out the repair work were E7018-1 electrodes. They were used for welding root, intermediate and capping passes with 3.2, 4 and 5 mm in diameters respectively. These electrodes are high quality basic electrode, particularly suitable for welding high strength low alloy steels. The typical weld metal is very resistant to hot cracking, with 30% elongation, 480 MPa of yield strength and 590 MPa of tensile strength (ESAB, 5thEd). Electrodes were baked in the oven at the temperature of 200 – 250°C for at least 2 hours before being transferred to the kiln in heated dry storage quiver. The welder started welding the outside bevel until completion. After that the inner part of bevel were ground off to remove dirty, inspected by dye penetrant to check for any crack and then welded using the same procedure. While welding, each layer deposited was hammered carefully over the whole length of the repair to relieve residual stresses and help in removing slag after every run. Any sticking slag was removed by grinding.

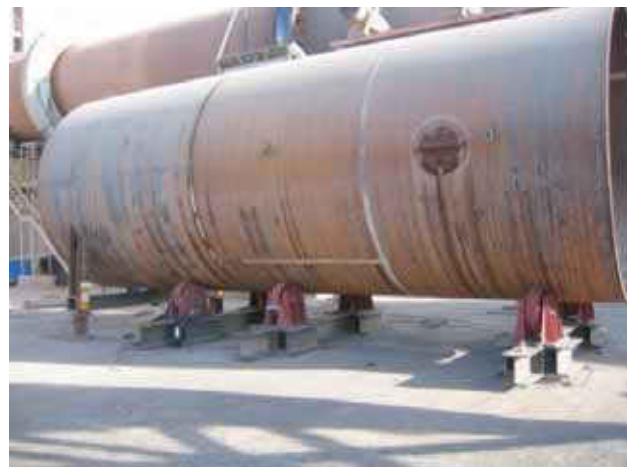
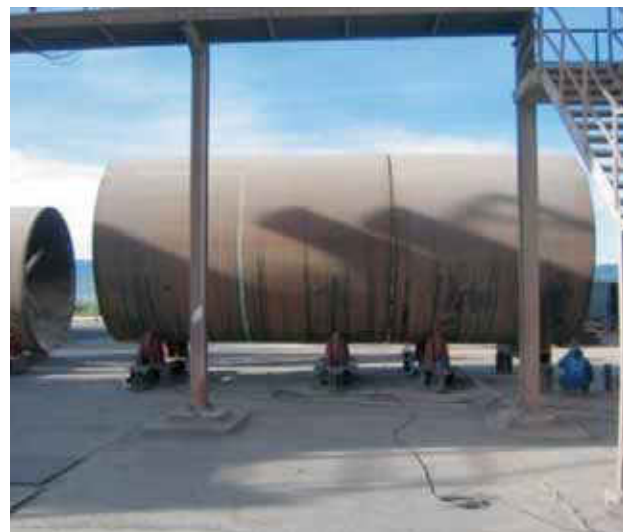
Fig. 12: New segments of kiln shell being welded on the ground before being hoisted into position.

The repaired kiln was in use for two years before the new sections with increased plate thickness were installed by first cutting off the damaged segment of the kiln shell, then the new three segments were joined together on the ground and lifted into position as shown in Figs. 12. The author of this article was a welding consultant on both projects namely the repairing of the cracked shell and the installation of the new shell segments.
