DEGRADATION OF WATERFRONT REINFORCED CONCRETE STRUCTURES AT THE PORT OF DAR ES SALAAM

I. P. L. Sanga, A. M. Dubi1 and J. J. Msambichaka
Institute of Marine Sciences & Faculty of Civil Engineering and Built Environment,
University of Dar Es Salaam

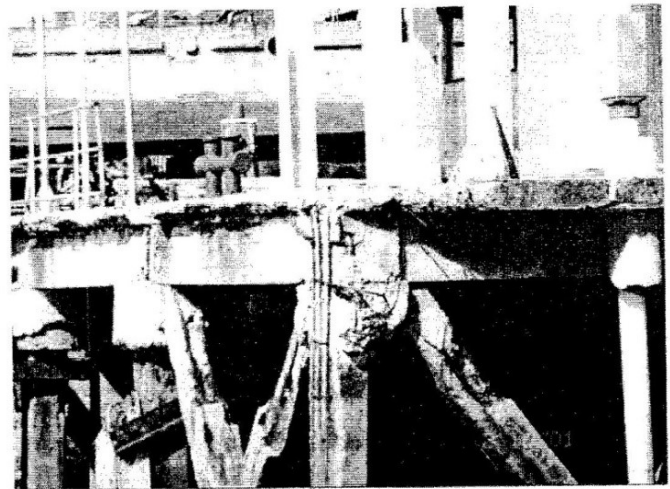
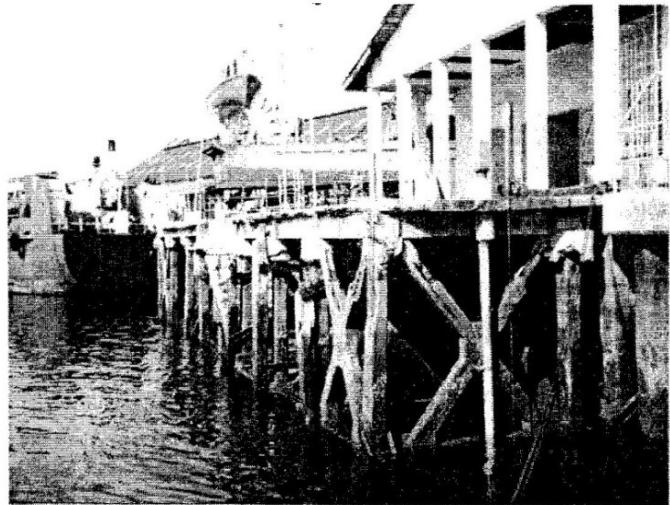
(a) The dhow quay at the Lighter wharf had concrete piers built during the Germany era. The structures at the terminal had been in use for about 100 years. The facility was in bad condition as the concrete had been badly damaged due to corrosion. Some of the elements of the structures had very wide cracks along the line of bars and most of the concrete on piers and struts had in some places substantially spalled and peeled-off in such away that the reinforcements were completely exposed (Plate 1).

Plate 1: Concrete piers and struts severely corroded at Lighter quay .

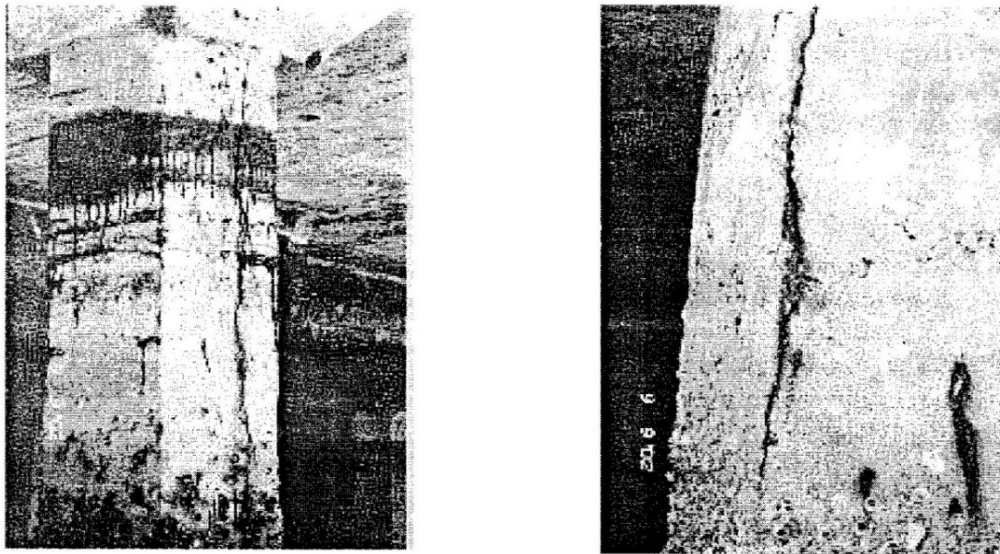
(c) Berths 4 to 11 at the main quay had concrete piers. Small to wide cracks of up to 20 mm were noted on concrete piers for all berths and some few piers were severely corroded

especially on Berth 6 through Berth 8 (Plate 2). Structures at the terminal were in poor condition as corrosion of the reinforcement steel was very significant such that some few elements of the concrete structures had spalled and peeled-off too an extent that the steel reinforcements were exposed to the air (Plate 3). In such unrepaired condition, the piers are expected to lose a major part of their design load bearing capacity and structural strength. The concrete cover ranged between 20 mm and 30 mm.

Plate 2: Typical cracks on concrete piers found on berth 4 through 8

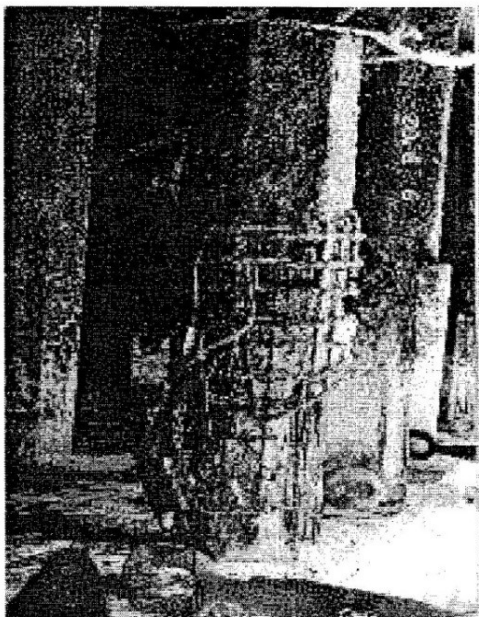
Plate 3: Exposed reinforcement in one of the piers at main quay

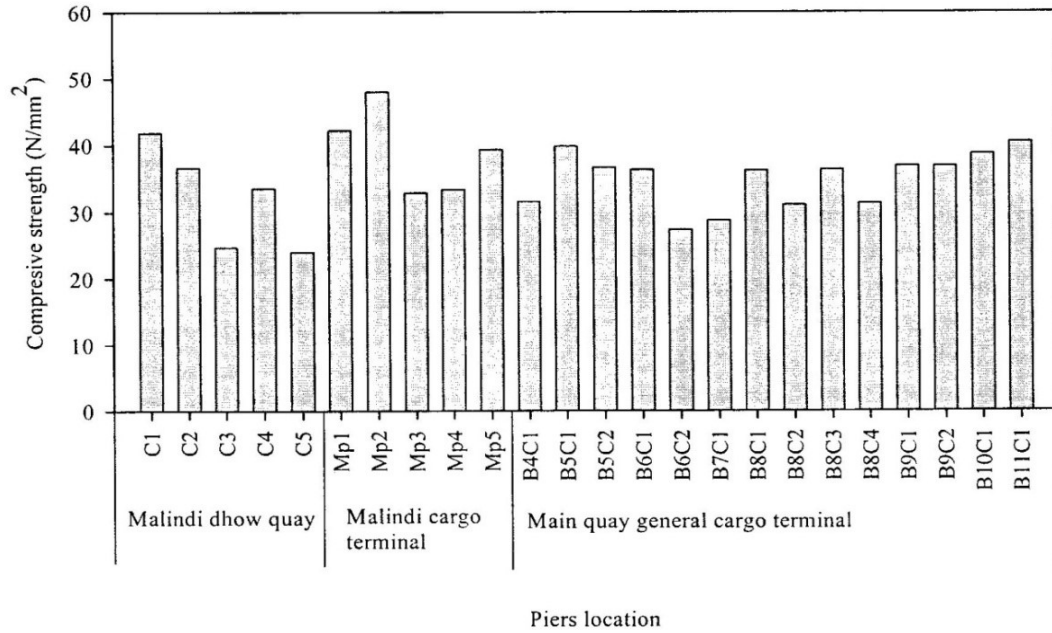
The maximum and minimum compressive strength for concrete piers as found according to rebound hammer at Lighter quay was 47.97 N/mm^2 and 24.01 N/mm^2 for Malindi cargo terminal and Malindi dhow quay respectively (Fig. 2). The mean compressive strength at Malindi cargo terminal was 39.13 N/mm^2 while at Malindi dhow quay was 32.13 N/mm^2 . At main quay the mean compressive strength was found to be 35.38 N/mm^2 (Fig. 2). Fig. 3 shows the comparison of compressive strength at different terminals. Concrete piers at Malindi cargo terminal have the highest strength with a maximum compressive strength of about 50 N/mm^2 . A minimum compressive strength of about 25 N/mm^2 was found at Malindi dhow quay.

Fig. 2: Insitu compressive strength on concrete piers at the port of Dar es Salaam

After obtaining field results it was not possible to compare with theoretical ones because the calculations and design information used in designing concrete structures at the port could not be found and therefore the actual water-cement ratios and cement contents of the concretes were not known. Nevertheless, according to the British Code of Practice, BS 8110, minimum concrete grade in seawater (very severe condition of exposure) is grade 40. The results obtained at Lighter – dhow quay showed that the concrete strength was 24.1 N/mm^2 which was well below the nominal concrete grade 40. The upper value of 42 N/mm^2 was slightly above the nominal concrete grade.

Results obtained at Malindi cargo terminal concrete piers showed that the strength ranged between 33 N/mm^2 and 48 N/mm^2 . Therefore the low value was slightly below the nominal concrete grade while the higher value was well above the nominal concrete grade. At the main quay (berth 4 to 11) most of the concrete piers had compressive strength which was lower than the nominal concrete grade 40, except for some very few cases that had slightly higher results than the nominal concrete grade 40 as they ranged between 28 N/mm^2 and 41 N/mm^2 . Therefore the rebound hammer results of relatively low values provided a preliminary indication of the poor structural integrity of the concrete structures.

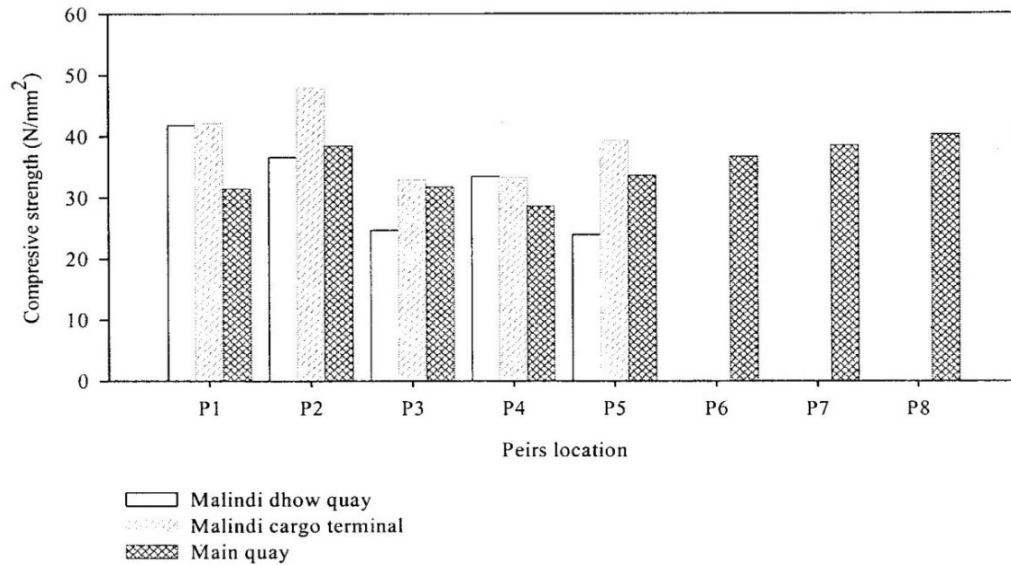
Fig. 3: Comparative insitu compressive strength for concrete piers as measured by rebound hammer at the port of Dar es Salaam
