RESTORATION OF HISTORIC BUILDINGS IN ZANZIBAR

John K. Makunza

ABSTRACT

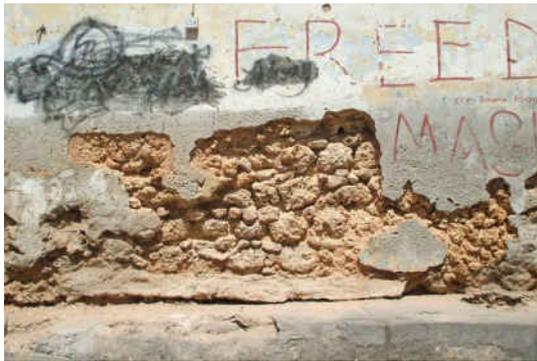
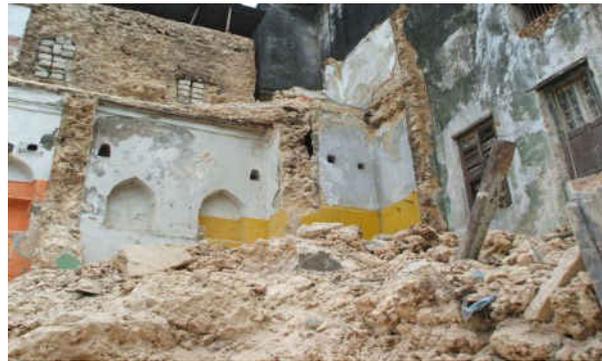
Figure 5: Deteriorated buildings

(a) Deteriorated mortar

(b) Collapsed building

Stone Town is a **World Heritage**; this means, it is a conserved area. One of the principles of conservation is to restore the buildings to their original status, using similar materials and design principle (Sandbhor and Botre, 2013). Looking at current state of most repaired historic buildings in Stone town it is quite clear that the repair attempts made have not been effective (see Figures 4 and 5).

Observing the facade of the historic buildings in Stone Town, Zanzibar, stone units still appear to be in good condition while mortar (joint mortar, plaster, render) present an extremely advanced deteriorated condition of the buildings as seen in Figures 4 and 5. Therefore, this shows that, there is no any comprehensive study undertaken so far on identifying the original materials used for construction and restoration techniques. Thus, there was a need to investigate on the materials used in these historic buildings so that the same type of materials and techniques would be identified and used for restoration purposes.
