Full Length Research Paper

Concrete Technology in a Rapidly Growing Urban Environment – The Case of Dar es Salaam City

John K. Makunza

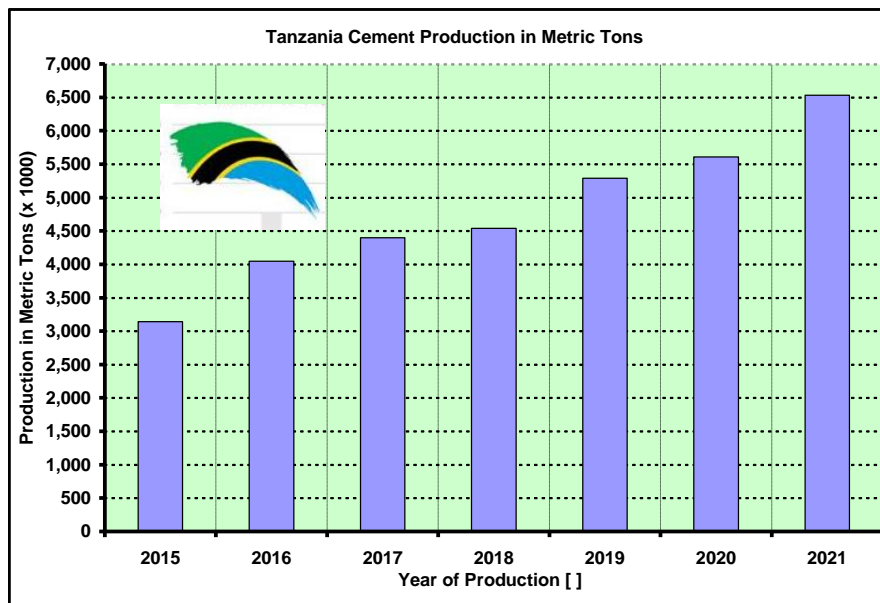
Figure 1: Tanzania Cement Production (Lars Kamer; 2022; www.tanzaniainvest.com/cement).

Tanzania's cement production reached 6.5 million tons (mt) in 2021, 16% more than in 2020 when the estimated cement market demand in Tanzania reached 5.9 million tons, including exports. The cement industry in Tanzania includes six integrated plants and several grinding facilities with a production capacity of around 11 million tons. Tanzania's largest cement producers are Tanzania Portland Cement (Twiga), Tanga Cement (Simba), and Dangote Cement. Dangote, Africa's leading cement producer, estimated Tanzania's total market sales to reach 6.2 mt in 2021 (Figure 1). It also noted that Tanzania's per capita

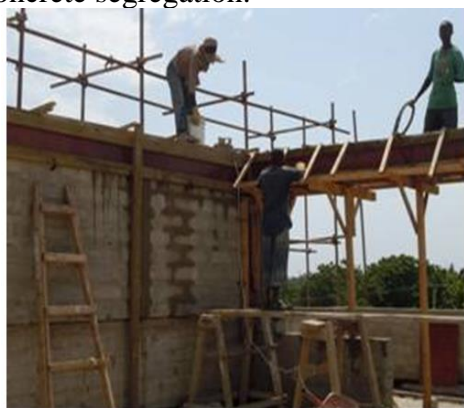
Figure 2: Typical appearance of mortar pan.

The use of mortar pan for transportation of concrete is one of the common methods adopted in this country. It is a labor-intensive method. In this case, concrete is carried in small quantities in pans or small containers. While this method minimizes the segregation to some extent, it suffers from the disadvantage that it exposes greater surface area of concrete to drying conditions. This results in loss of water, particularly, in hot weather conditions. It is to be noted that each mortar pan must be wetted prior to use and it must be kept clean during the entire operation of concreting. Mortar pan method of conveyance of concrete can be adopted for concreting at the ground level, but below or above the ground level (Figure 2) it is difficult as it may lead to concrete segregation.

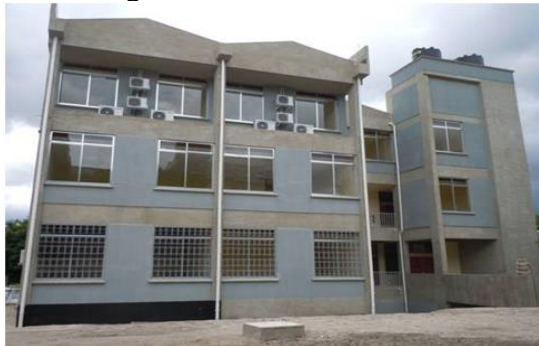
Figure 3: Structure made fro RMC at UDSM.

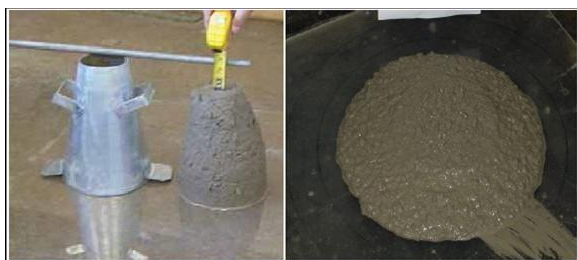
Figure 4: Slump and flow of concrete.

W/C ratio	0.4	0.45	0.5	0.56
Spread diameter SCC [mm]	550	562	570	583
Slump NVC [mm]	59	62	67	78

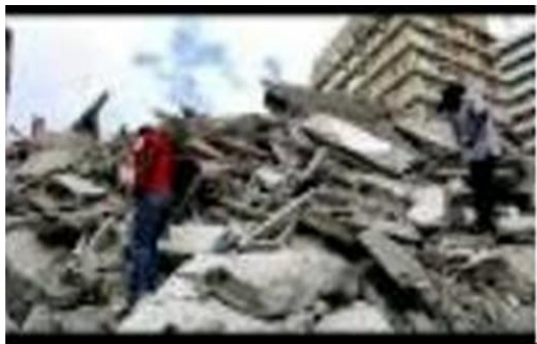
Figure 5: Collapsed building rubbles.

This building depicted in Figure 5 collapsed while under construction process on 29th March 2013 at 8.30 am killing 36 people. The Government formed a probe team combining the Engineers Registration Board (ERB), Contractors Registration Board (CRB), and Architects and Quantity Surveyors Board (AQRB) and members from other Government institutions and local Government. The team sought for a consultant who performed the investigation, after which he reported as detailed below:

- Concrete lumps from rubbles looked to be weak – reflecting poor concrete mix ratio
- Reinforcement bars were corroded, the phenomenon which gives implication of poor compaction of concrete and improper water-cement ratio.
- The actual plan of the existing basement on site was different from the design drawings.
- Orientation of columns directions were altered from the original design.
- Aggregates used for retaining walls, slabs and beams look soft coral rock while that for basement foundation and columns was strong granite rock of origin.
- Some rotten timber elements were seen at the collapsed building – giving indication that probably rotten formwork was mixed with fresh formwork.

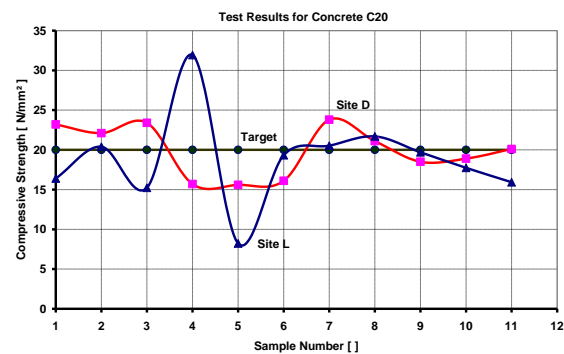
Figure 6: Test results collected from DIT and TBS Laboratories.

Data from various sites were sampled among many available data for buildings which were still in the construction stage. Hence sites L and D which had a design strength of concrete grade C20 (CP 110, 1972) were first sampled. On analyzing the results as shown in Figure 6, it was found that the mean compressive strength values were 19.9N/mm^2 and 18.8N/mm^2 respectively, being below the standard. The general trend shown in Figure 6 indicates that the compressive strength of concrete does not meet the requirements of strength value of concrete grade C20.

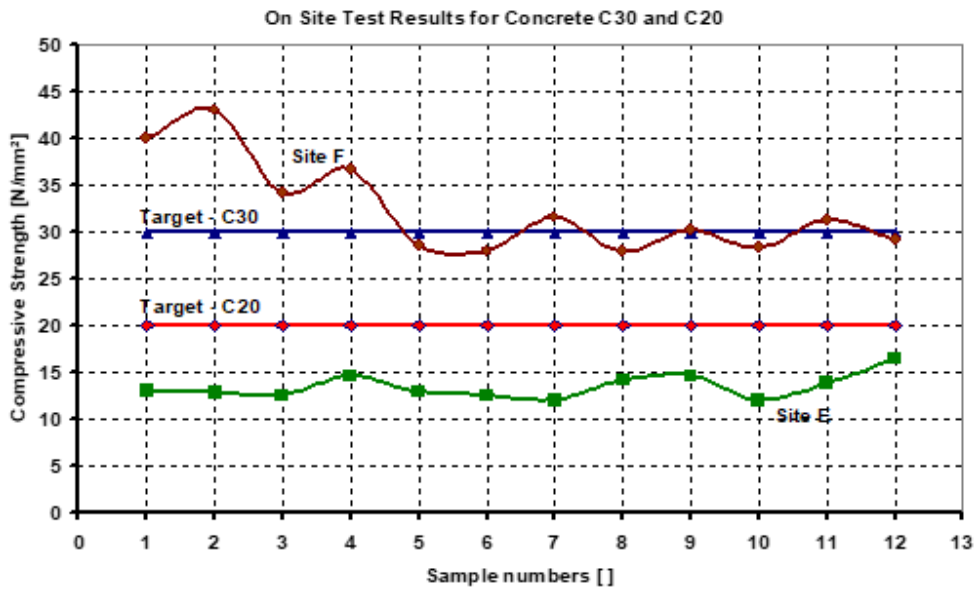
Figure 7: Compressive strength of concrete from Sites E and F.

presented in Figure 7 where there are four graphs; two showing the specification strength values of 20N/mm^2 and 30N/mm^2 , and the achieved strengths with regard to the two concrete grades from tested beams, slabs and columns. With regard to Site E and specified strength of concrete grade C20, all

12 test results obtained are below the standard. After interviewing confidentially on adherence to the specifications, the foremen responded that they did not send any sample for testing in any laboratory. For site F, the design strength was $f_{cu} = 30\text{N/mm}^2$ (Mwingizi, 2019). The obtained results showed that out of twelve test points, a half of the test results values were below the standard.
