CASE STUDIES: IN-SITU REBUILDING OF DAMAGED ROPE DRUM SHAFTS OF SSG CRANE AND THE REPAIR OF CIRCUMFERENTIAL CRACK OF CEMENT KILN BY WELDING.

Joseph Runyoro

CASE STUDY 1 RECONDITIONING OF DN 240 ROPE HOIST DRUM SHAFT OF A SHIP TO SHORE GANTRY CRANE.

CASE NO 2. WELDING OF THE CIRCUMFERENTIAL CRACKS OF WELDED JOINT OF THE CEMENT KILN

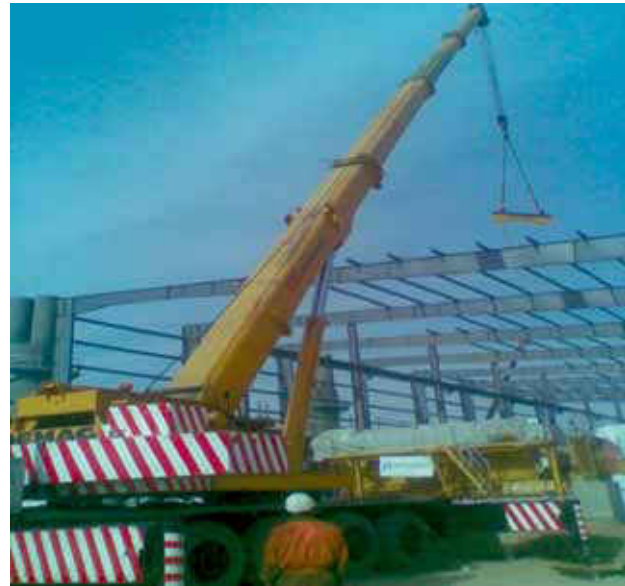
The biggest crane was 150 Ton with the capability of hoisting 135 Ton at 5m radius and with a maximum boom extension of 42 m carrying 15 Tons at 10 m radius and 5 Tons at 20 m radius (Fig. 2). In order to lower the drum, the boom extension should be at least 50 m in length. Even if it was brought down, there was no lathe machine in Tanzania capable of machining the part after welding.

Fig. 2: The biggest crane available at that time was 150 Ton crane with the maximum boom span of 42 m.
